# 2023 Condition Assessment

City of Buhl, MN  
Cone Top Tank  
100,000 Gallon Elevated

Inspection Date: January 2, 2024  
Water System Consultant: Jim Olson

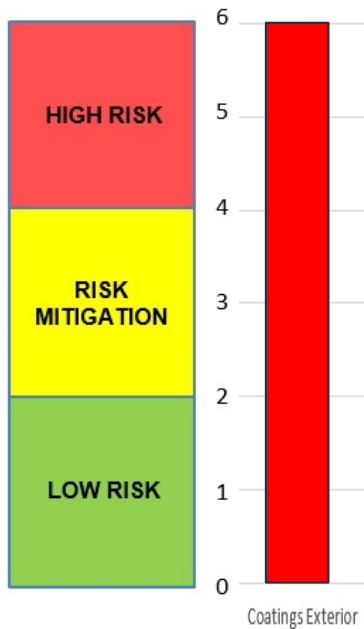
- Exterior Coating Condition is Poor
- Heavy Corrosion occurring on the sidewall
- Delamination present on the legs & roof
- Heavy chalking from UV

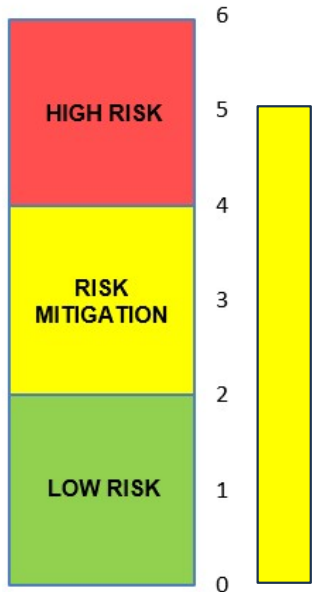
- Overall Water Chamber Coatings Condition is Fair
- Moderate crevice corrosion is present on several ceiling weld seams
- Mild corrosion occurring on the ceiling rods
- Significant amount of sediment was present  
Washouts are recommended once every 2 years

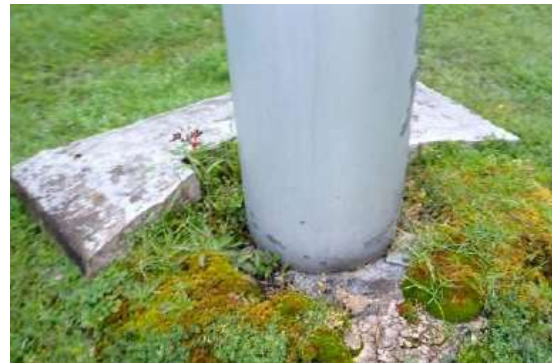
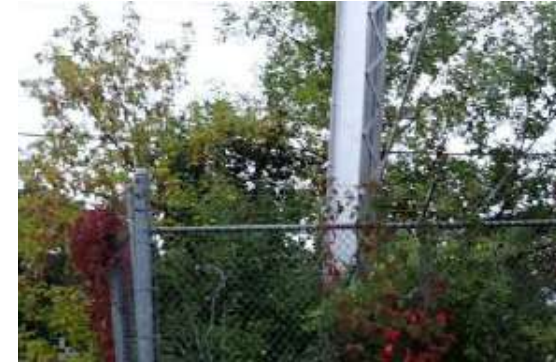
- Concrete Riser Foundation repair suggested (damage is present, partially covered by grass)
- A tank leg is surrounded by small trees & bushes (remove trees & bushes to prevent coatings damage)
