City of Buhl, MN

CONDITION ASSESSMENT REPORT

Cone Top Tank

October 4, 2023

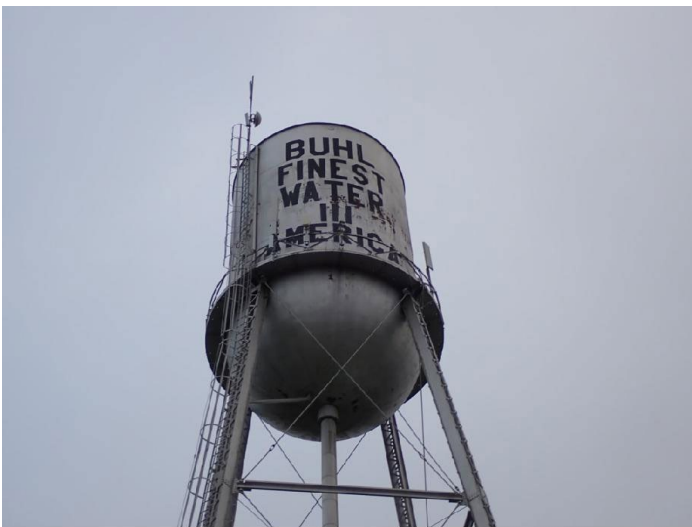
The tank exterior is in poor condition. Heavy corrosion is occurring on all areas of the exterior sidewall. There is significant delamination occurring on multiple tank legs and on the exterior surface of the tank roof. The adhesion is currently stable but is beginning to show signs of failure. The coating is also heavily chalked due to UV degradation. It is recommended that an exterior renovation be scheduled immediately.

View of tank exterior

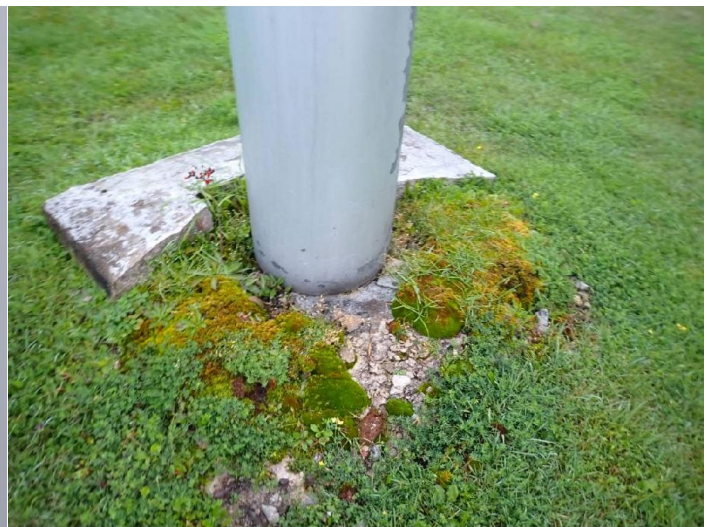
The concrete tank leg foundations all appear to be in good condition with no apparent signs of cracking or erosion. However, the concrete riser foundation is significantly damaged and partially covered by grass and soil. It is recommended that the riser foundation be repaired.

Exterior riser and tank foundation

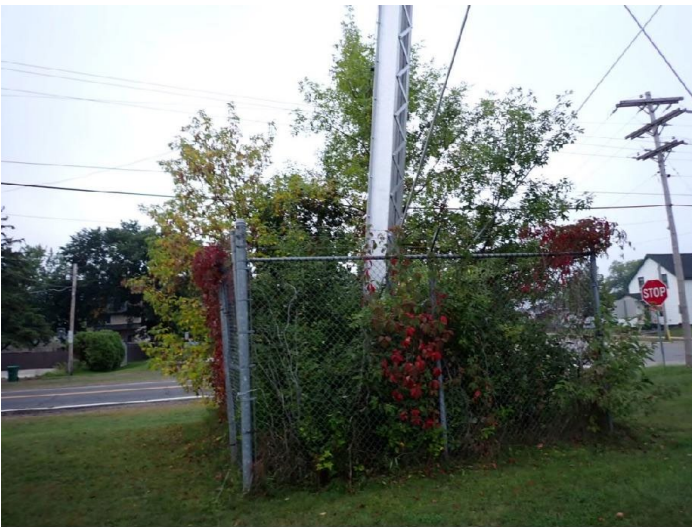
One of the tank legs is completely surrounded by small trees and large bushes. It is recommended that this excess vegetation be removed to prevent continuous brushing against the coating system on the tank leg.

Tank leg surrounded by vegetation

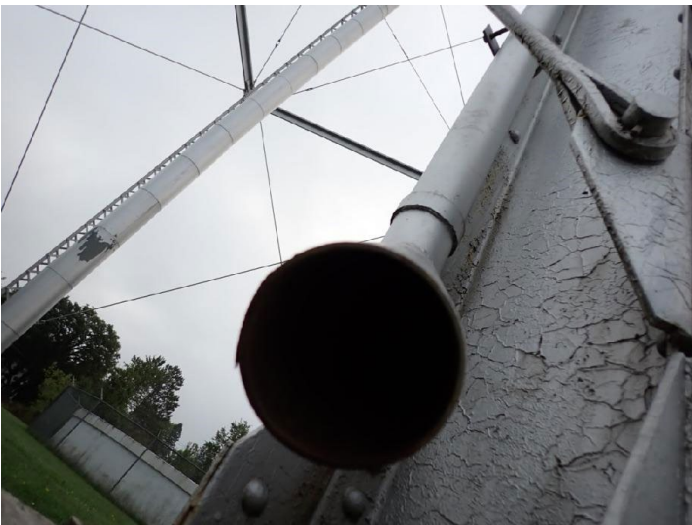
The roof vent is in good condition and the vent screen is fully intact and functioning properly. The overflow system is also in good condition but it is recommended that a flapper valve/mesh screen combination assembly be installed at the termination point to prevent insect contamination.

Overflow termination point

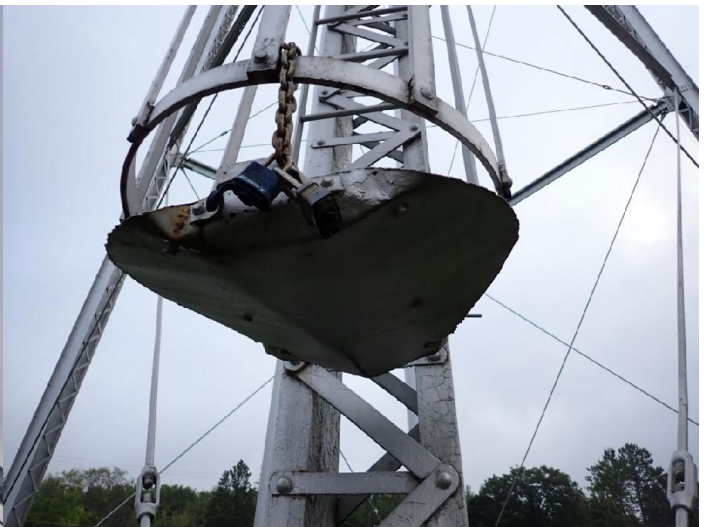
All access ladders are in good condition with no apparent signs of damage or deficiencies. It is recommended that flex cable safety climb devices be installed on all exterior ladders. The ladder gate on the tank leg access ladder is heavily damaged and it is recommended that the ladder gate be replaced.

Ladder gate

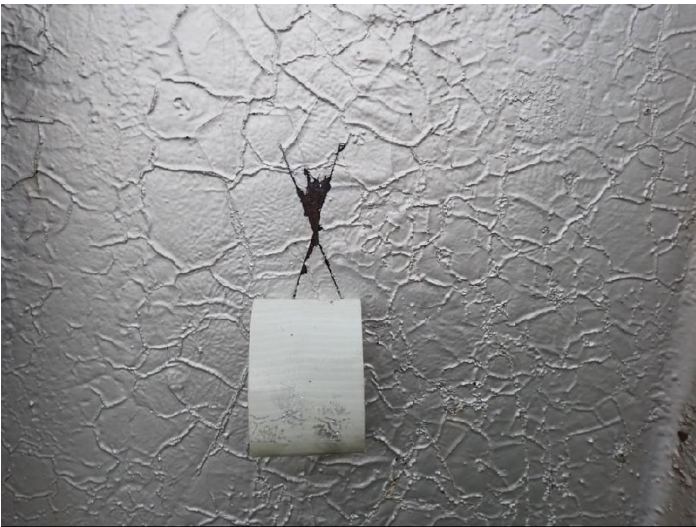
Adhesion test result

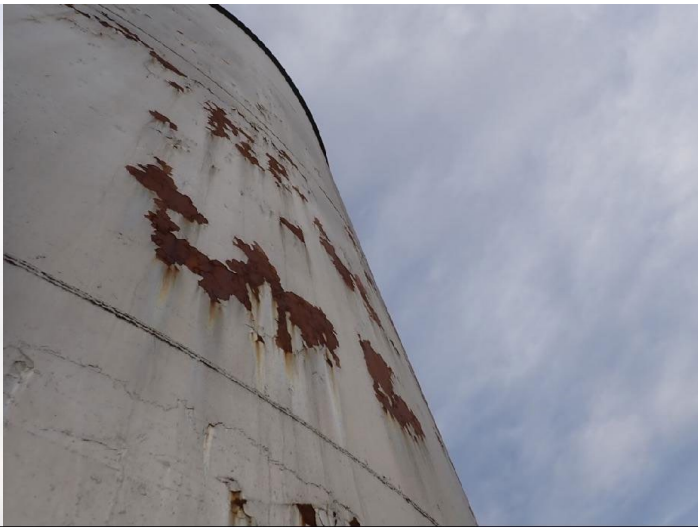
Sidewall and corrosion

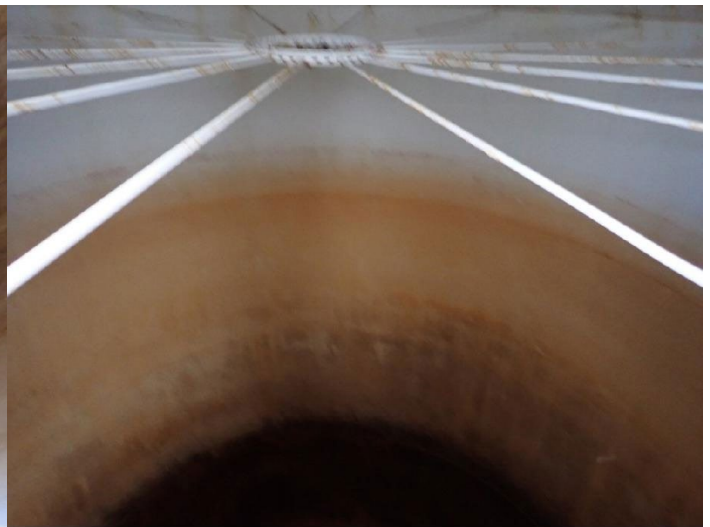
Overall, the tank interior is in fair condition. Moderate crevice corrosion was detected on multiple ceiling weld seams. There is also mild corrosion occurring on the ceiling rods.

Interior ceiling and sidewall

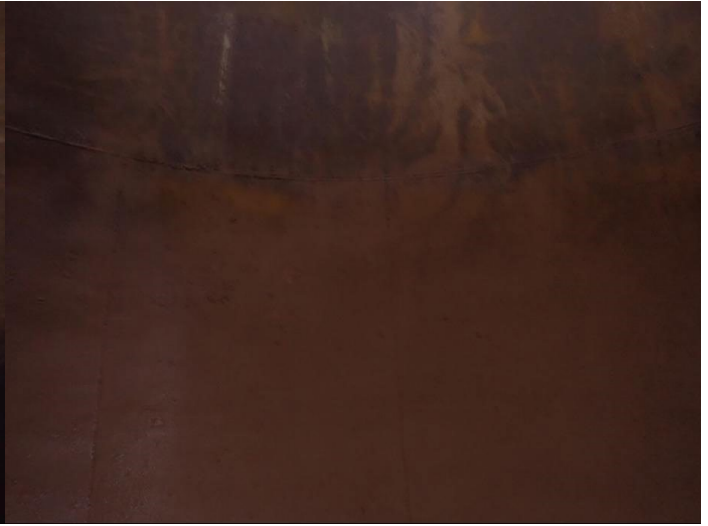
The interior tank surface below the water line is completely covered in heavy staining. This staining could not be removed through pressure washing and is too thick to allow for a thorough inspection of the tank floor. The visible areas of the tank floor and lower sidewall appear to be in fair condition with no apparent signs of major corrosion. It is recommended that a chemical cleaning be performed to fully remove the staining.

Lower sidewall before washout

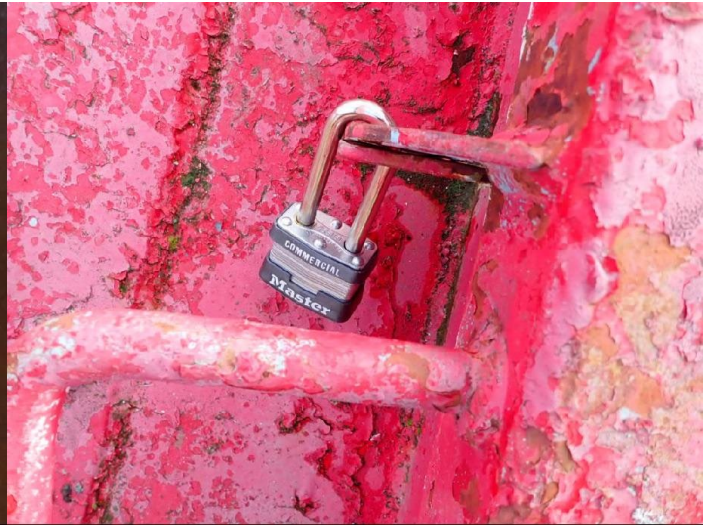
The roof access hatch is also in good condition with no signs of corrosion or damage. The roof hatch was closed but not locked at the time of inspection. A lock was placed on the roof hatch by the inspector on-site.

Roof hatch w/ lock
