Re: City of Buhl Water Tower Assessment
AMI Project No: 241117

We are pleased to present the results of AMI Consulting Engineers, P.A.'s (AMI) structural inspection of the City of Buhl water tower, located in Buhl, Minnesota. This inspection focuses on evaluating the current condition and remaining service life of the water tower's structure. Also included in this report are recommendations for maintenance, repairs, and future inspections aimed at prolonging the service life of the structure. The following is a summary of the findings and recommended actions.

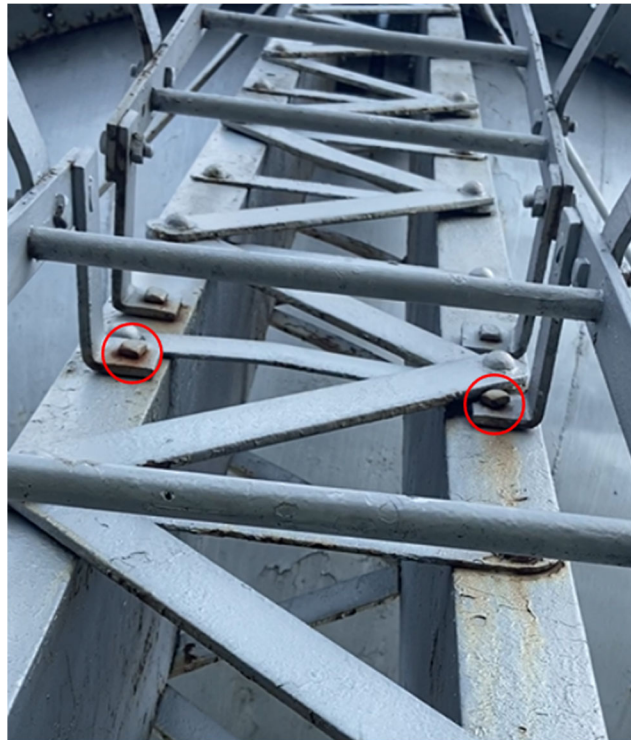
Figure 1. Loose bolts near ladder splice.

6. Seal the hairline cracks on the concrete foundation.
7. Perform a visual inspection of the structure conducted by a engineer every 10 years.
8. Repair the loose section of the fixed ladder.

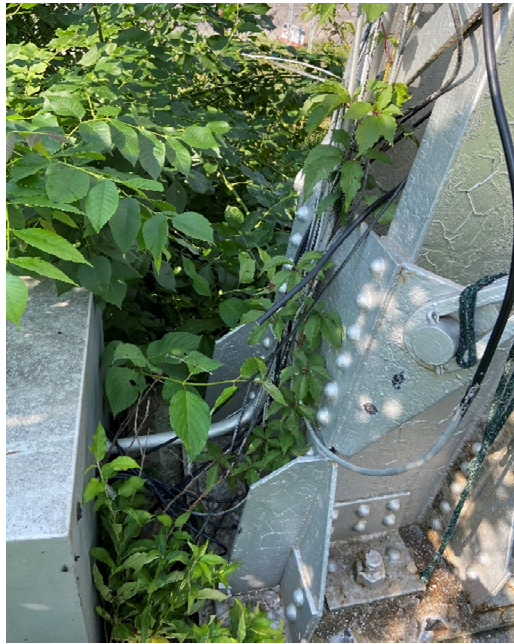
Again, the structural steel is generally in good condition with negligible section loss and sporadic light surface corrosion. Little to no pack rust was observed during the inspection. AMI noted that the column base plates and the steel near the water tank tend to have more surface corrosion due to greater moisture exposure compared to the rest of the structure. For example, AMI noticed large amounts of vegetation around the electrical box near the southeast footing (Figure 2). The inspection team observed standing water on the base plate and footing near the overgrowth. This is to be expected as it is a common problem for all baseplates.

Figure 2. Dense vegetation surrounding the southeast footing.

4. Clear vegetation around electrical station near the southeast footing (Figure 8) within 1 year. Continue to keep this area clear of vegetation.
5. Sandblast (or similar) and repaint the structure within the next 5 years. Be sure to develop a paint specification with the help of a paint manufacturer or professional engineer. Continue to maintain the new coating in accordance with the paint manufacturers' recommendations.

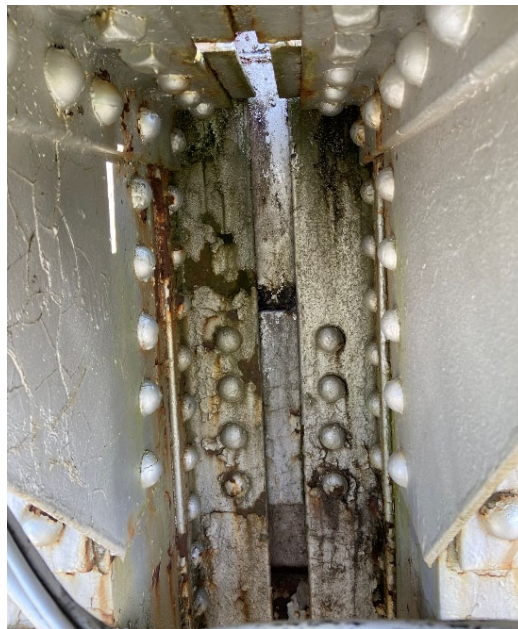
Additionally, AMI observed condensation forming on the tank and running onto the steel below. The area between the gusset plates that support the walkway seemed to have more surface corrosion. (Figure 3)

Figure 3. Light corrosion at southwest column-to-tank connection.

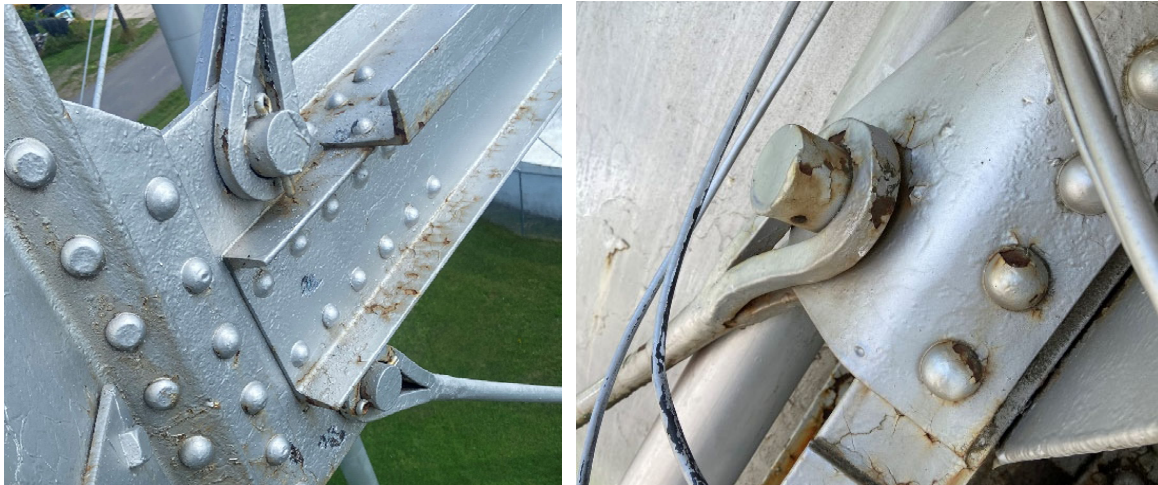
AMI documented several locations with loose cross bracing. The bracing was shaken by hand to test tightness, which revealed that some rods are excessively loose. During hot summer days, you would expect the rods to thermally expand and loosen up, but the amount of play observed appeared to be beyond that resulting from thermal expansion alone. When the inspector was near the top of the tower, he could feel the tower react to a moderate wind gust by swaying and then “catching” on the diagonal bracing. Additionally, several cotter pins that are used to positively secure the brace rods pin to the columns were missing (Figure 4). When tightening the cross-bracing rods, it is important not to over tighten the rods because the steel will contract on cold days. Ensure that the contractor performing the work has experience with tension cross bracing and follows the proper industry guidelines.

Figure 4. Typical diagonal brace clevis & cotter pin connection & connection with missing cotter pin.

1. Replace missing cotter pins on the cross-bracing pins within 1 year.
2. Replace buckled lacing bars located on the columns within 1 year.
3. Re-tighten the cross-bracing rods using the existing turnbuckles within 1 year.

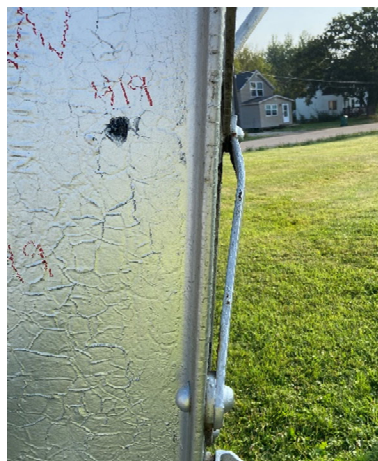
AMI observed several buckled lace bars near the base of the structure. Steel laces were buckled outward, away from the center of the column (Figure 5). It is unclear when this damage occurred or what caused it in the first place. There did not seem to be any damaged lace bars farther up the columns. The northwest column’s baseplate was also bent upward in one corner (Figure 6). This damage probably took place during construction but is not a concern for the longevity of the structure.

Figure 5. Buckled lace near the base of the northwest column

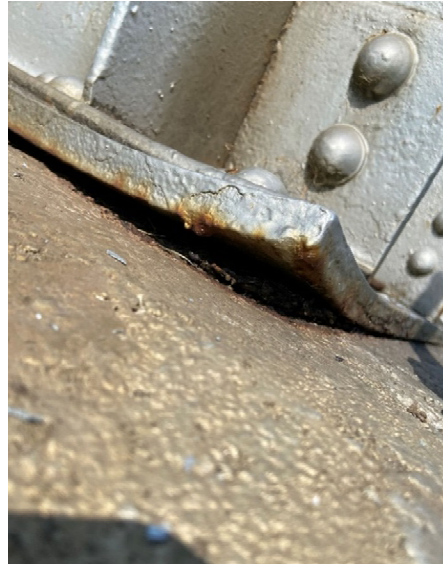
Figure 6. Bent base plate corner on the northwest column.

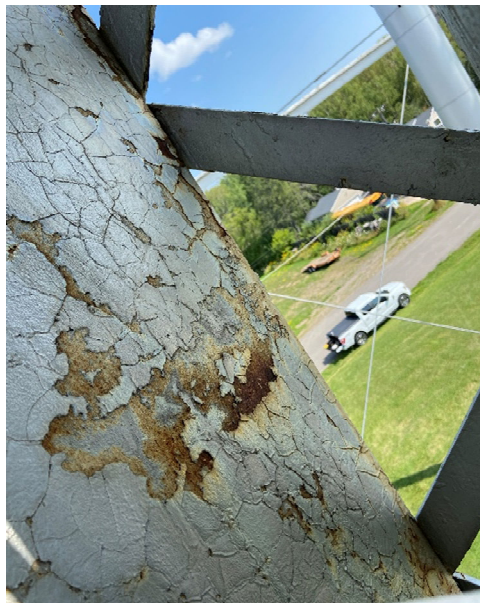
Overall, the steel coating is in poor condition. Paint cracks were observed over the majority of the structure. Some areas had large areas of chipped paint. (Figure 7) Other areas had smaller holidays where the paint had delaminated from the steel and air pockets have formed underneath the coating. A functional coating system is crucial to protecting the structural steel from corrosion. When selecting a replacement coating, it is best practice to work with a paint manufacturer or an engineer to select the proper paint system and identify the correct surface preparation and application procedures.

Figure 7. Cracked and flaking paint on the southwest column.

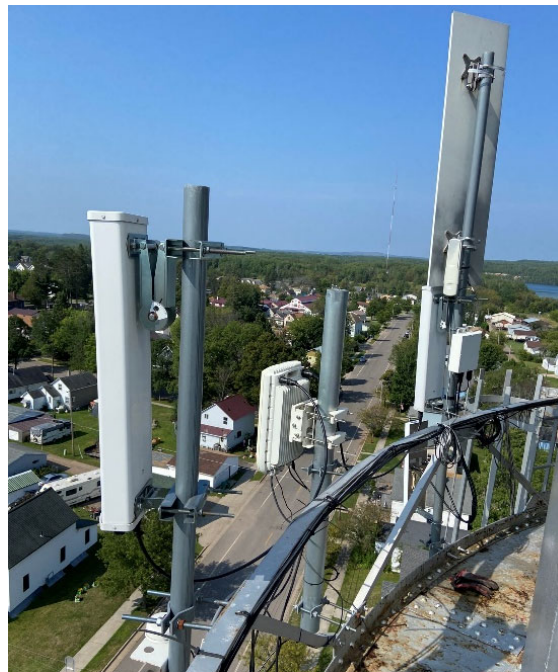
Finally, AMI observed several communications antennas attached to the guardrail at the top of the tower (Figure 8). We cannot say whether these antennas are properly supported. AMI is unaware of any authorization given by an engineer to support antennas from the structure. Best practice is to obtain a letter signed by a professional engineer licensed in the state of Minnesota from the service provider stating that the existing structure can adequately support the loads induced by the antennas.

Figure 8. Several antennas attached to the walkway guardrail.

11. Obtain a letter from the antenna service provider stating that the existing structure is adequate to support the antenna loads.
