# 2023 Condition Assessment

City of Buhl, MN  
Cone Top Tank  
100,000 Gallon Elevated

Inspection Date: January 2, 2024  
Water System Consultant: Jim Olson

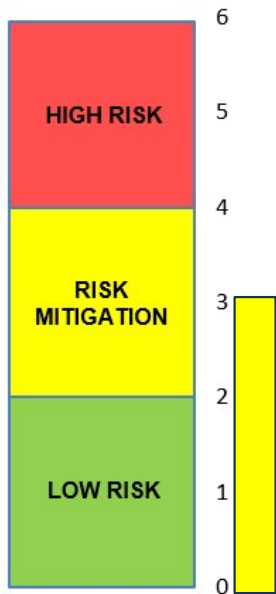
# SAFETY & SECURITY

- Install new cable safety climb
- Remove existing ladder cage
- Install new ladder gate (existing is heavily damaged)

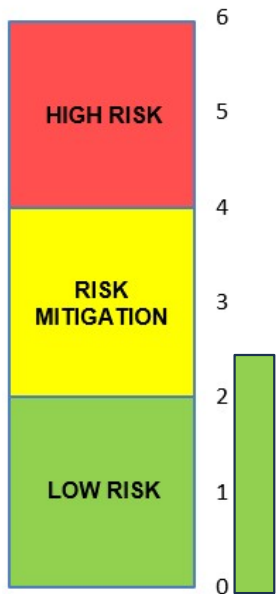
# STRUCTURAL

- Concrete Riser Foundation repair suggested (damage is present, partially covered by grass)
- A tank leg is surrounded by small trees & bushes (remove trees & bushes to prevent coatings damage)
