City of Buhl, MN

CONDITION ASSESSMENT REPORT

Cone Top Tank

October 4, 2023

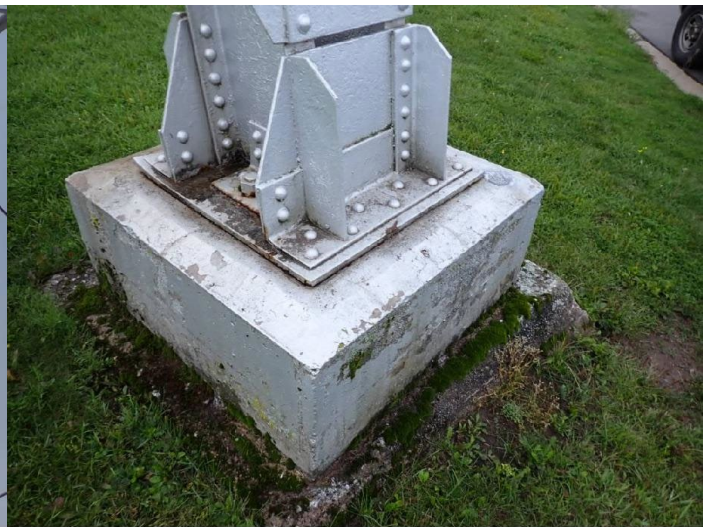
Tank leg and foundation

The concrete tank leg foundations all appear to be in good condition with no apparent signs of cracking or erosion. However, the concrete riser foundation is significantly damaged and partially covered by grass and soil. It is recommended that the riser foundation be repaired.

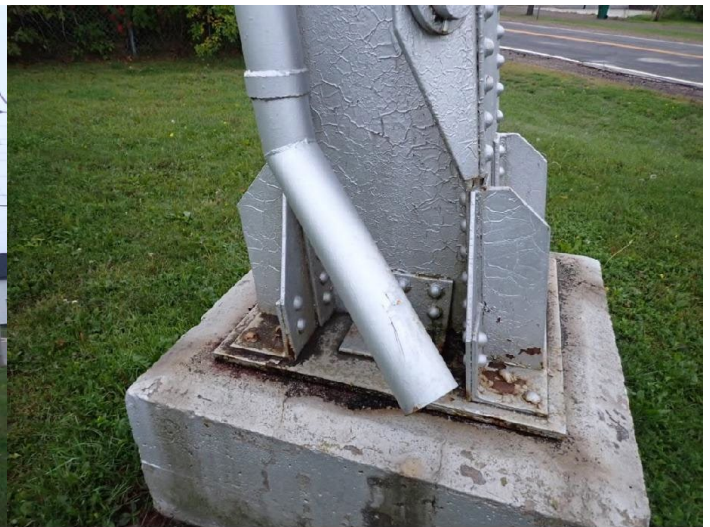
Overflow pipe

The roof vent is in good condition and the vent screen is fully intact and functioning properly. The overflow system is also in good condition but it is recommended that a flapper valve/mesh screen combination assembly be installed at the termination point to prevent insect contamination.

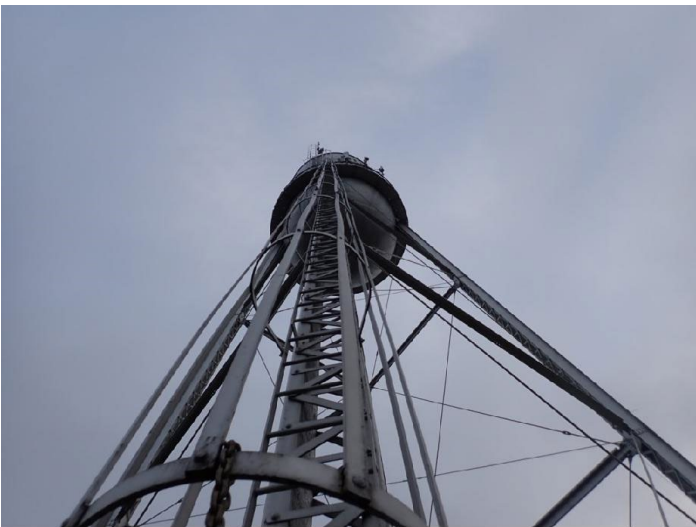
Tank leg ladder

All access ladders are in good condition with no apparent signs of damage or deficiencies. It is recommended that flex cable safety climb devices be installed on all exterior ladders. The ladder gate on the tank leg access ladder is heavily damaged and it is recommended that the ladder gate be replaced.

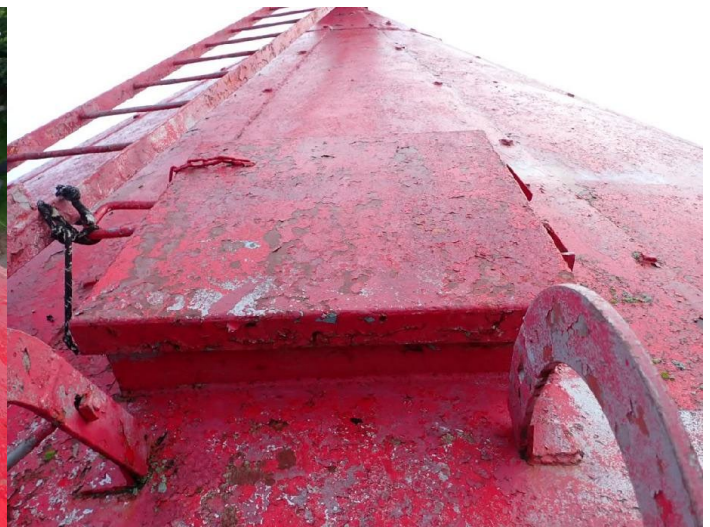
Roof access hatch

The roof access hatch is also in good condition with no signs of corrosion or damage. The roof hatch was closed but not locked at the time of inspection. A lock was placed on the roof hatch by the inspector on-site.

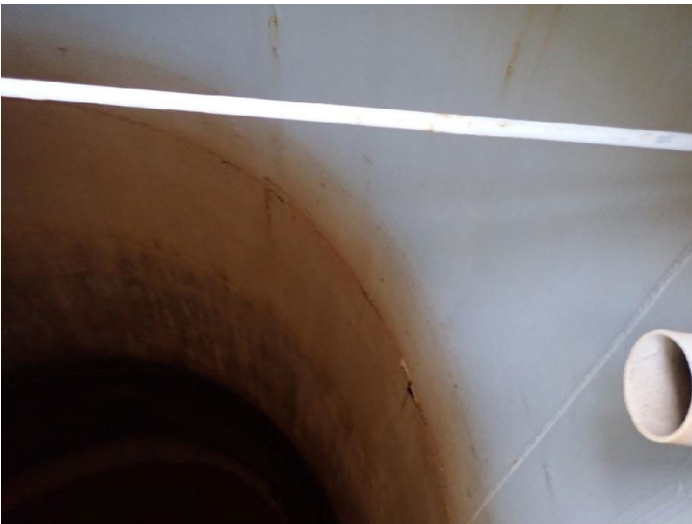
Interior sidewall

Overall, the tank interior is in fair condition. Moderate crevice corrosion was detected on multiple ceiling weld seams. There is also mild corrosion occurring on the ceiling rods.

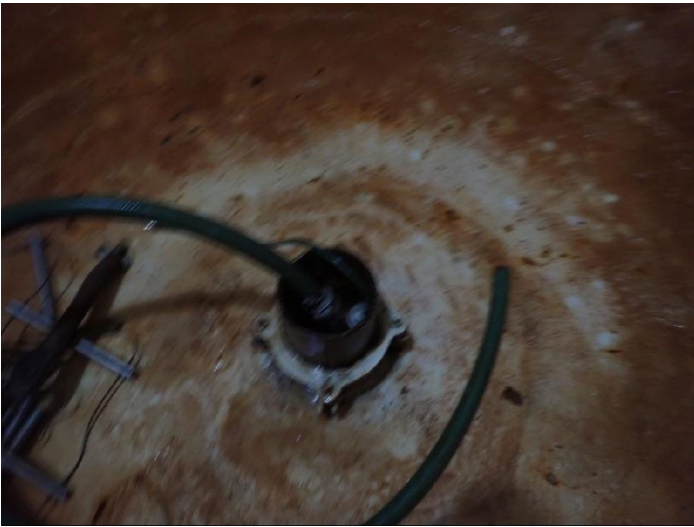
Tank floor after washout

The interior tank surface below the water line is completely covered in heavy staining. This staining could not be removed through pressure washing and is too thick to allow for a thorough inspection of the tank floor. The visible areas of the tank floor and lower sidewall appear to be in fair condition with no apparent signs of major corrosion. It is recommended that a chemical cleaning be performed to fully remove the staining.
