Re: City of Buhl Water Tower Assessment
AMI Project No: 241117

We are pleased to present the results of AMI Consulting Engineers, P.A.'s (AMI) structural inspection of the City of Buhl water tower, located in Buhl, Minnesota. This inspection focuses on evaluating the current condition and remaining service life of the water tower's structure. Also included in this report are recommendations for maintenance, repairs, and future inspections aimed at prolonging the service life of the structure. The following is a summary of the findings and recommended actions.

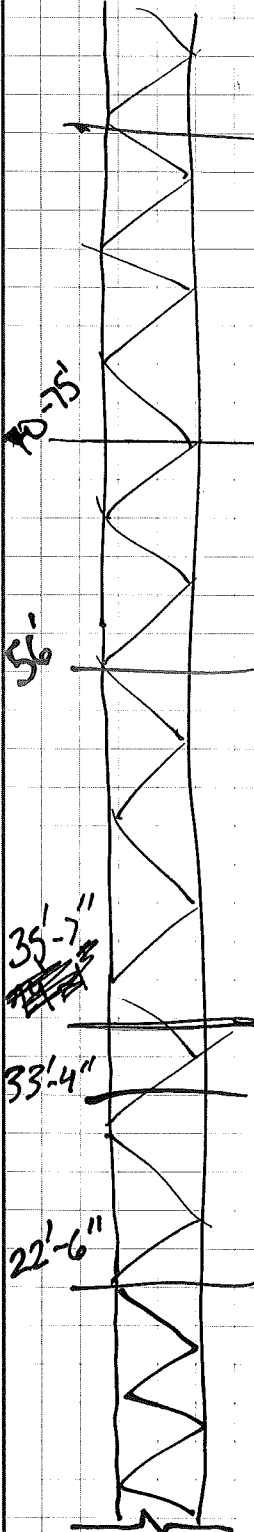
PROJECT	BUHL WATER TOWER INSPECTION		
DESCRIPTION	STRUT MEMBER DIMENSIONS		
ENGINEER	AMI PROJ. NO.	APPROVED	DATE
			8/18/24

Lattices: 0.406, 0.412, 0.383, 0.396, 0.402, 0.395

Web L: 0.404, 0.416, 0.405
